Flood Control Project Maintenance
Levee Inspections

Fall 2012 Levee Maintenance Deficiency Summary Report

Sacramento River Basin

Brannan Andrus Levee Maintenance District

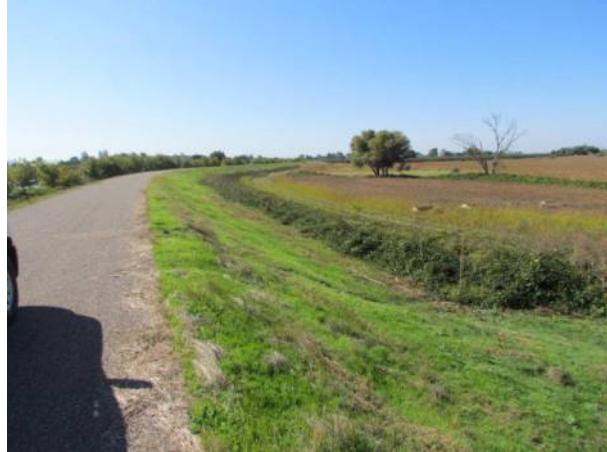
Levee Mile Report Line	4
Start Levee Mile	0.50
End Levee Mile	0.75
Location	Land Side
Category	Earthen Levee
Item	Vegetation
Looking southwest at wild roses or berryvines on landside toe.	
richard_f_20121012_199.jpg

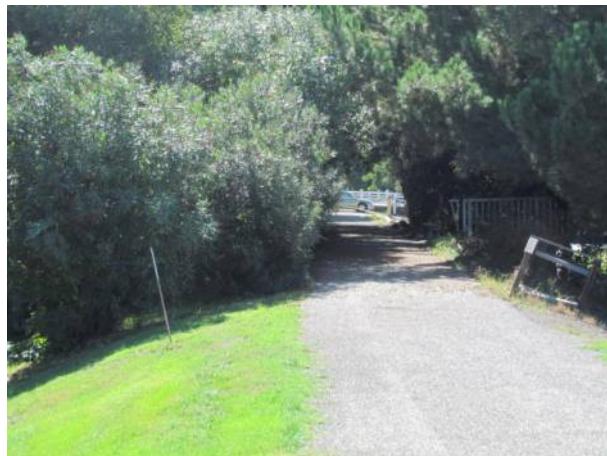
Levee Mile Report Line	7
Start Levee Mile	2.29
End Levee Mile	2.34
Location	Land Side
Category	Earthen Levee
Item	Vegetation
Looking south at dense landscape on waterside and landside of levee.	
richard_f_20121012_212.jpg

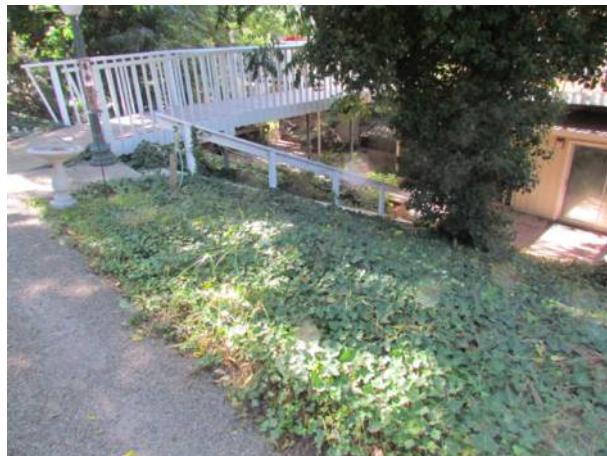
Levee Mile Report Line	7
Start Levee Mile	2.29
End Levee Mile	2.34
Location	Land Side
Category	Earthen Levee
Item	Vegetation
Looking west at ground cover on landside slope.	
richard_f_20121012_213.jpg

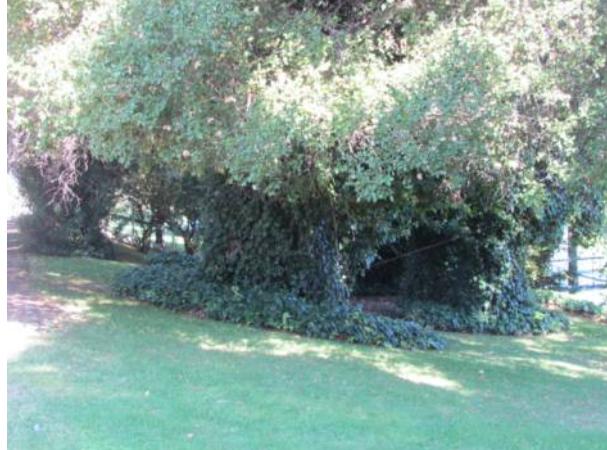
Levee Mile Report Line	7
Start Levee Mile	2.29
End Levee Mile	2.34
Location	Land Side
Category	Earthen Levee
Item	Vegetation
Looking north at dense vegetation on waterside slope.	
richard_f_20121012_214.jpg

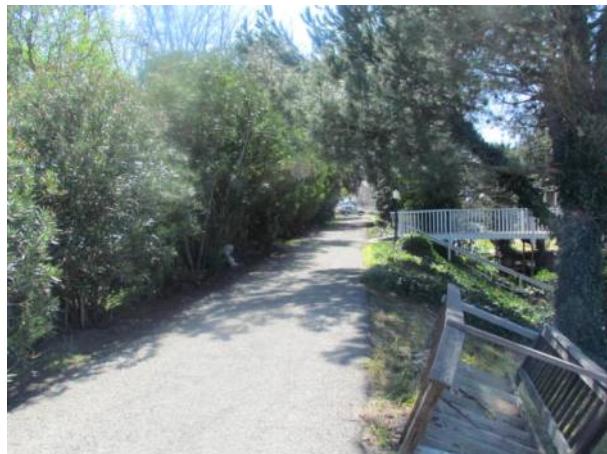
Levee Mile Report Line	7
Start Levee Mile	2.29
End Levee Mile	2.34
Location	Land Side
Category	Earthen Levee
Item	Vegetation
Looking south at dense oleander on waterside shoulder spring 2012	
richard_f_20121012_215.jpg

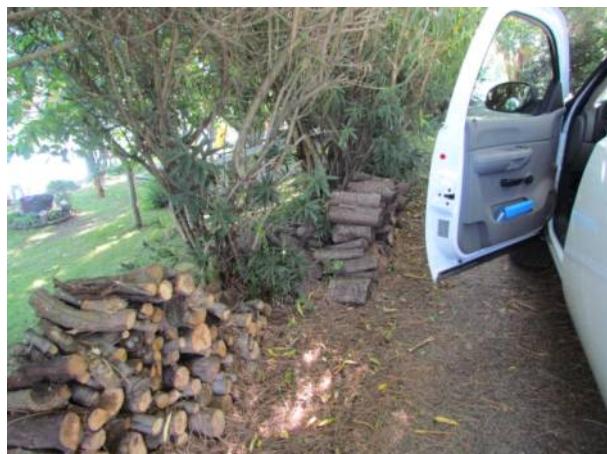
Levee Mile Report Line	8
Start Levee Mile	2.30
End Levee Mile	2.30
Location	Water Side
Category	Earthen Levee
Item	Encroachments
Looking east at firewood on waterside shoulder.	
richard_f_20121012_200.jpg

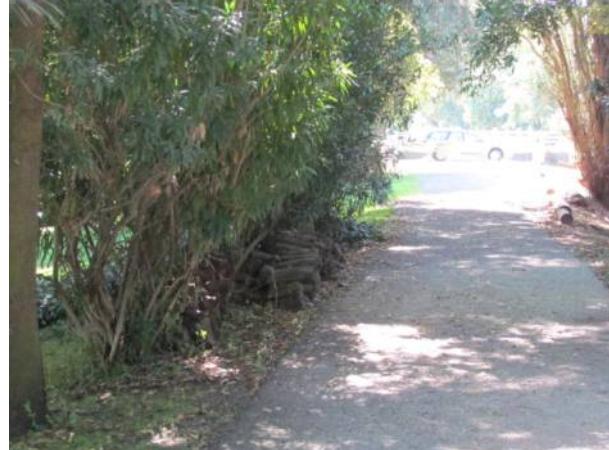
Levee Mile Report Line	8
Start Levee Mile	2.30
End Levee Mile	2.30
Location	Water Side
Category	Earthen Levee
Item	Encroachments
Looking south at firewood on waterside shoulder.	
richard_f_20121012_201.jpg

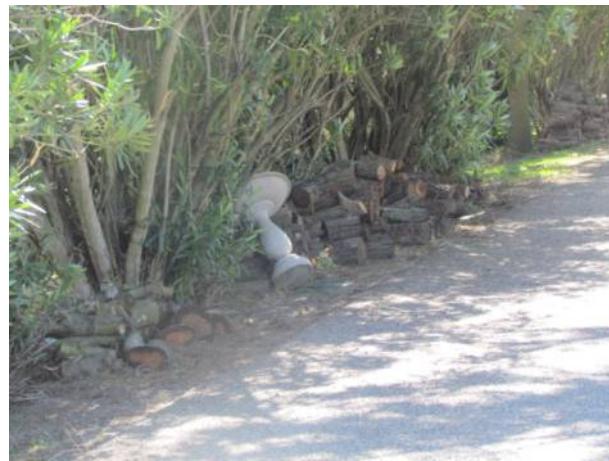
Levee Mile Report Line	8
Start Levee Mile	2.30
End Levee Mile	2.30
Location	Water Side
Category	Earthen Levee
Item	Encroachments
Looking southeast at firewood on waterside shoulder.	
richard_f_20121012_202.jpg

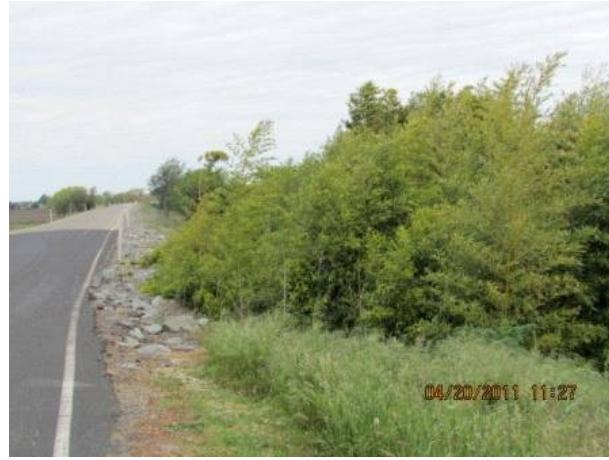
Levee Mile Report Line	13
Start Levee Mile	3.93
End Levee Mile	3.93
Location	Water Side
Category	Earthen Levee
Item	Vegetation
Looking west at dense vegetation on waterside slope.	
richard_f_20121012_204.jpg

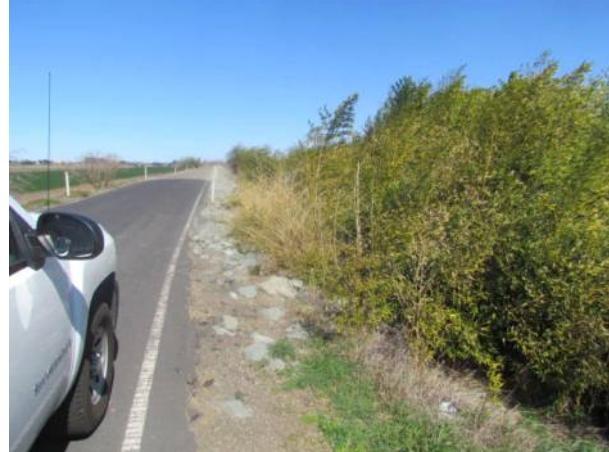
Levee Mile Report Line	13
Start Levee Mile	3.93
End Levee Mile	3.93
Location	Water Side
Category	Earthen Levee
Item	Vegetation
Looking west at dense vegetation on waterside slope spring 2012.	
richard_f_20121012_205.jpg

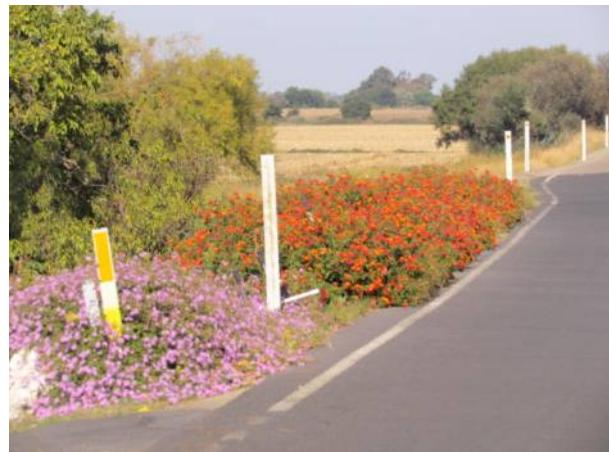
Levee Mile Report Line	14
Start Levee Mile	3.93
End Levee Mile	3.97
Location	Land Side
Category	Earthen Levee
Item	Vegetation
Looking northeast at landscape on landside slope.	
richard_f_20121012_206.jpg

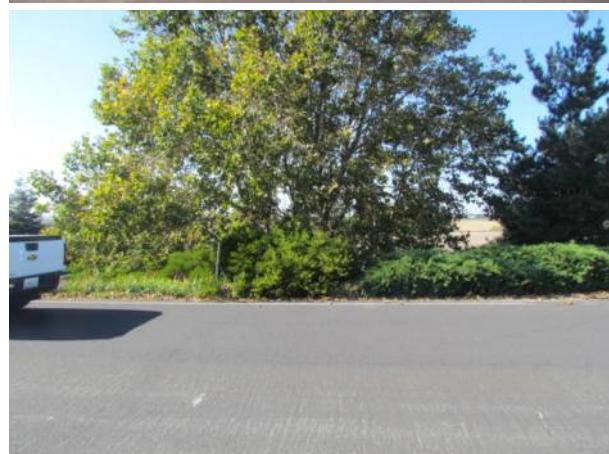
Levee Mile Report Line	14
Start Levee Mile	3.93
End Levee Mile	3.97
Location	Land Side
Category	Earthen Levee
Item	Vegetation
Looking west at dense landscape on landside slope.	
richard_f_20121012_207.jpg

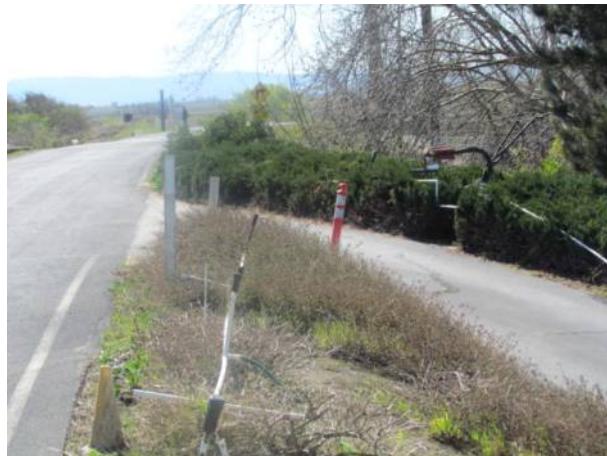
Levee Mile Report Line	14
Start Levee Mile	3.93
End Levee Mile	3.97
Location	Land Side
Category	Earthen Levee
Item	Vegetation
Looking south at brushes on landside shoulder and slope.	
richard_f_20121012_208.jpg

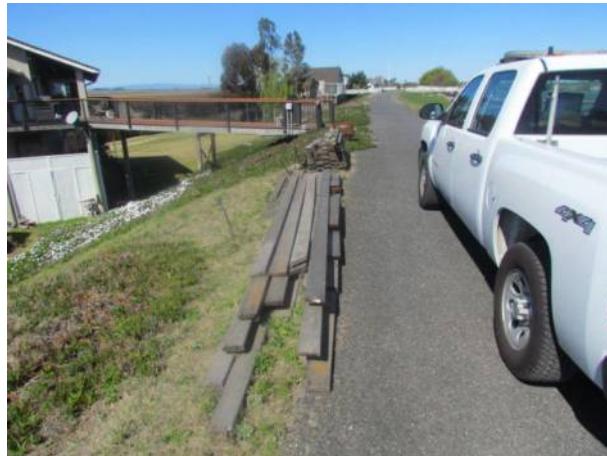
Levee Mile Report Line	18
Start Levee Mile	4.78
End Levee Mile	4.78
Location	Land Side
Category	Earthen Levee
Item	Encroachments
Looking northwest at wooden boards on landside shoulder.	
richard_f_20121012_211.jpg

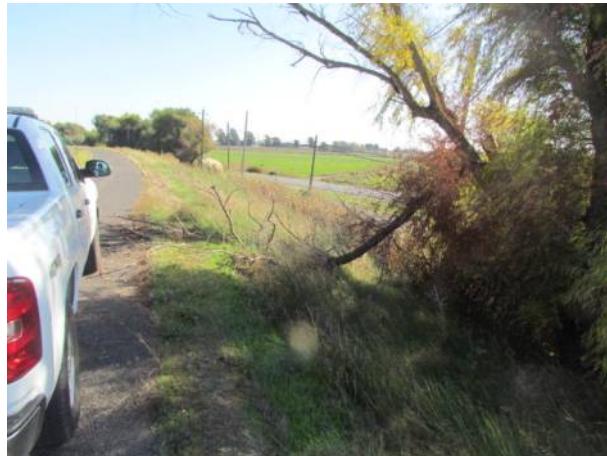
23	5.42	5.42	Earthen Levee	Encroachments	LS Ma	TR : Tree or limb Inspector Comments: Downed tree limb on landside slope.		38.130355 ° -121.588942 °	38.130355 ° -121.588942 °	4				
								DWR ID: DWR_NA0002_01_s_2012_4						
24	5.46	5.57	Earthen Levee	Vegetation	LS Ma	V2 : Remove the wild growth other than native grasses from the levee slopes. Inspector Comments: Remove vegetation at landside toe.		38.129810 ° -121.588218 °	38.129325 ° -121.586448 °	23				
								DWR ID: DWR_NA0002_01_s_2012_23						
25	5.63	5.67	Earthen Levee	Vegetation	WS Ma	V2 : Remove the wild growth other than native grasses from the levee slopes. Inspector Comments: Wild roses or berryvines on waterside slope.		38.129240 ° -121.585328 °	38.129252 ° -121.584723 °	18				
								DWR ID: DWR_NA0002_01_s_2012_18						
26	5.69	5.69	Earthen Levee	Vegetation	WS Ma	V2 : Remove the wild growth other than native grasses from the levee slopes. Inspector Comments: Willows on waterside slope		38.129307 ° -121.584253 °	38.129307 ° -121.584253 °	19

Levee Mile Report Line	23
Start Levee Mile	5.42
End Levee Mile	5.42
Location	Land Side
Category	Earthen Levee
Item	Encroachments
Looking southwest downed tree limb on landside slope.	
richard_f_20121012_203.jpg

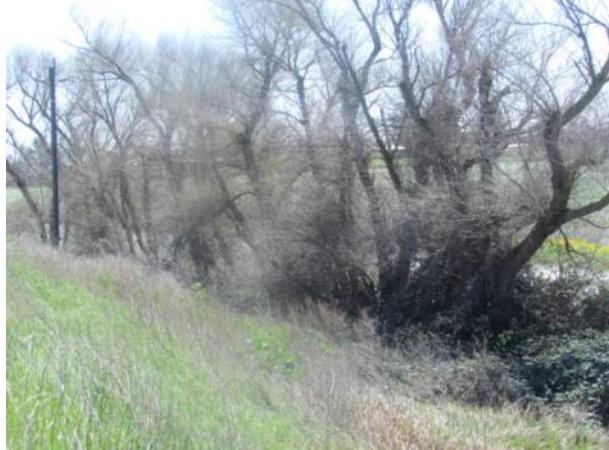
Levee Mile Report Line	24
Start Levee Mile	5.46
End Levee Mile	5.57
Location	Land Side
Category	Earthen Levee
Item	Vegetation
Looking south at trees and berryvines and wildrose on landside toe.	
richard_f_20121012_210.jpg

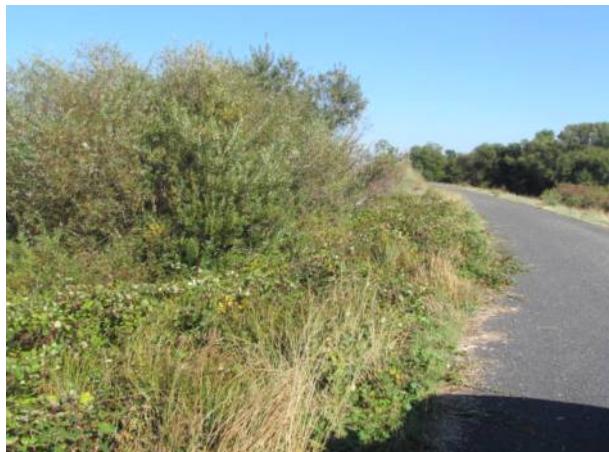
Levee Mile Report Line	25
Start Levee Mile	5.63
End Levee Mile	5.67
Location	Water Side
Category	Earthen Levee
Item	Vegetation
Looking south at dense vegetation on waterside slope.	
richard_f_20121012_209.jpg

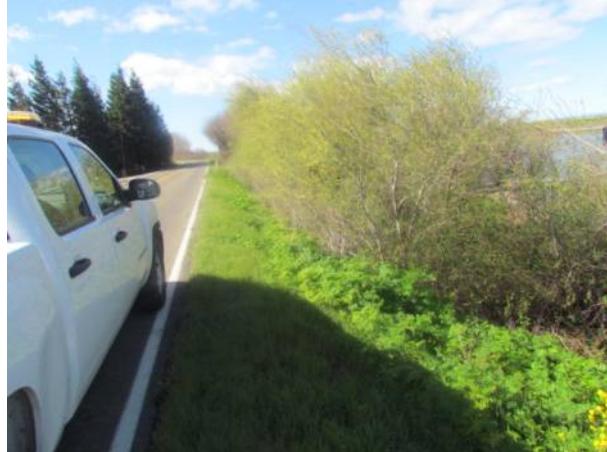
Levee Mile Report Line	3
Start Levee Mile	0.78
End Levee Mile	0.83
Location	Water Side
Category	Earthen Levee
Item	Trim / Thin Trees
Looking south at dense vegetation on waterside slope.	
richard_f_20121012_216.jpg

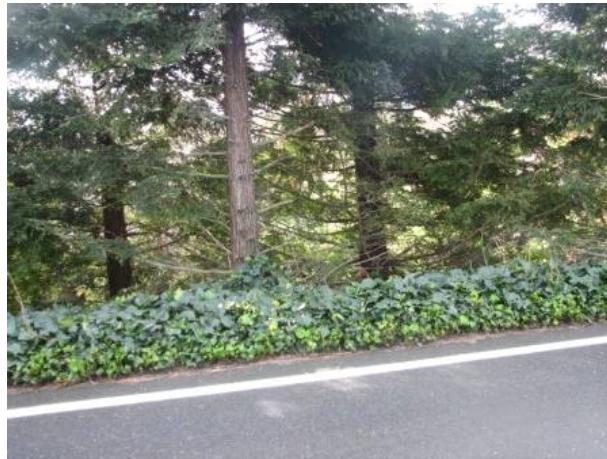
Levee Mile Report Line	4
Start Levee Mile	0.81
End Levee Mile	0.83
Location	Land Side
Category	Earthen Levee
Item	Vegetation
Landscaping on landside slope blocking view of slope from LM .81 to 0.83.	
richard_f_20121012_218.jpg

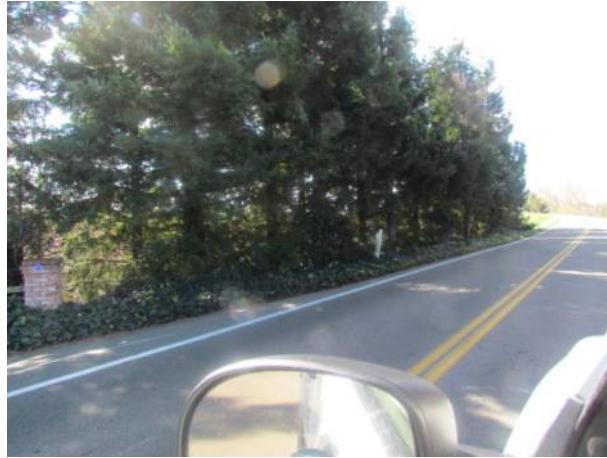
Levee Mile Report Line	4
Start Levee Mile	0.81
End Levee Mile	0.83
Location	Land Side
Category	Earthen Levee
Item	Vegetation
Looking southeast at dense landscaping on landside slope.	
richard_f_20121012_219.jpg

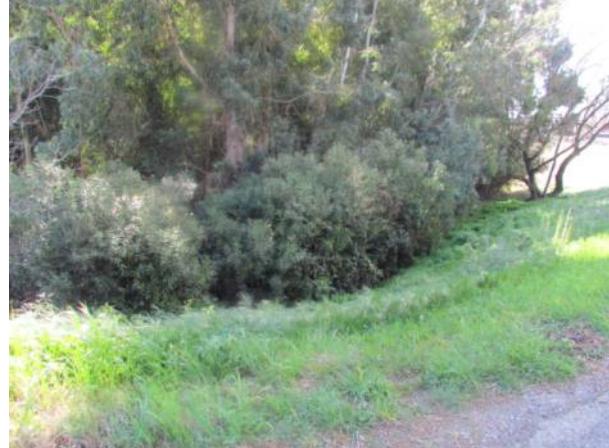
Levee Mile Report Line	5
Start Levee Mile	1.44
End Levee Mile	1.44
Location	Land Side
Category	Earthen Levee
Item	Trim / Thin Trees
Looking southeast at dense trees on landside toe.	
richard_f_20121012_238.jpg

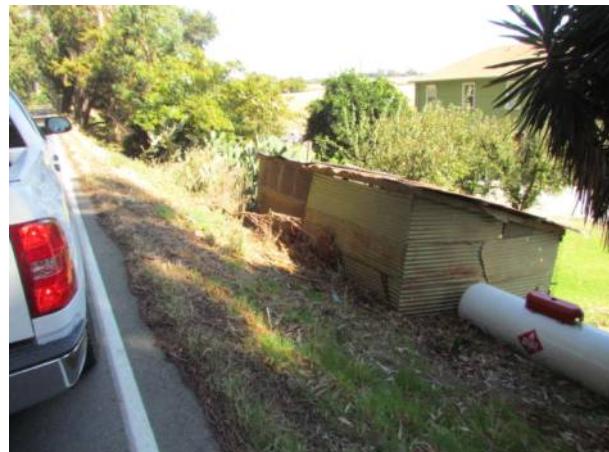
Levee Mile Report Line	10
Start Levee Mile	1.83
End Levee Mile	1.83
Location	Land Side
Category	Earthen Levee
Item	Encroachments
Looking northeast pump shed on landside toe.	
richard_f_20121012_239.jpg

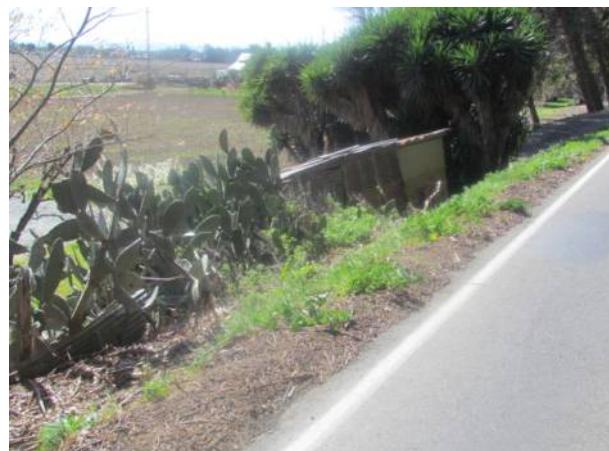
Levee Mile Report Line	10
Start Levee Mile	1.83
End Levee Mile	1.83
Location	Land Side
Category	Earthen Levee
Item	Encroachments
Looking southeast at pump shed and landscaping on landside slope and toe.	
richard_f_20121012_240.jpg

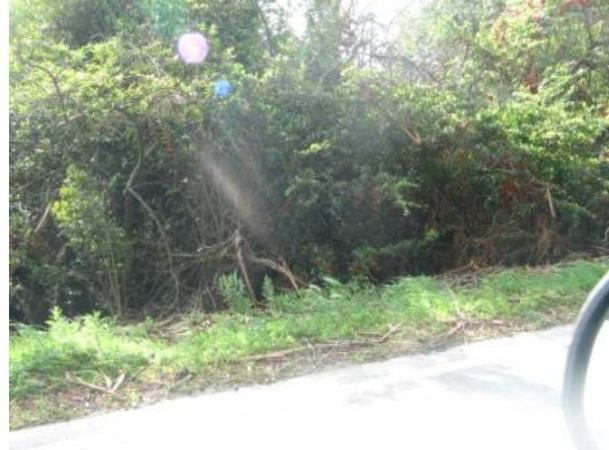
Levee Mile Report Line	12
Start Levee Mile	1.91
End Levee Mile	1.95
Location	Land Side
Category	Earthen Levee
Item	Vegetation
Landscaping on landside slope blocking view of slope from LM 1.91 to 1.95.	
richard_f_20121012_221.jpg

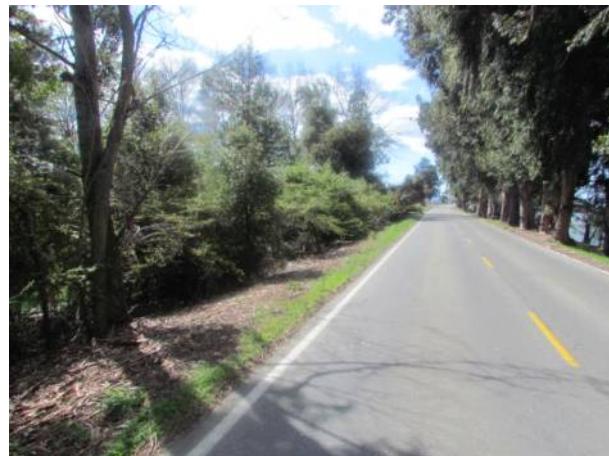
Levee Mile Report Line	12
Start Levee Mile	1.91
End Levee Mile	1.95
Location	Land Side
Category	Earthen Levee
Item	Vegetation
Looking south at dense landscaping on landside slope and toe.	
richard_f_20121012_222.jpg

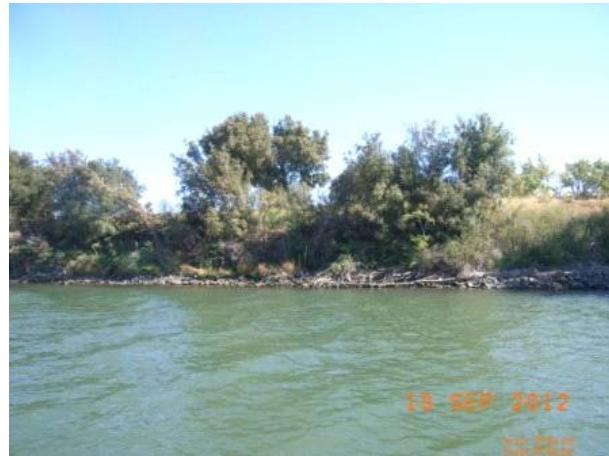
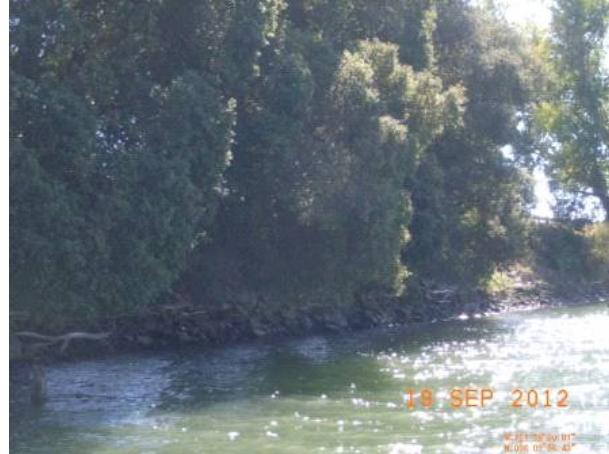
Levee Mile Report Line	15
Start Levee Mile	2.59
End Levee Mile	2.63
Location	Water Side
Category	Supplemental
Item	USACE Erosion Survey
USACE 2012 Photo #1	
USACE2012_SAC_18-1_L_1.jpg

-121.597570 °	-121.597570 °		
								DWR ID: DWR_NA0002_02_s_2012_29			
15	2.59	2.63	Supplemental USACE Erosion Survey	WS	M	Ma	Inspector Comments: 2009 - Short reach of vertical bank at the toe. 2010 - Large tree is getting ready to fall in. 2012: No observed change. [2012 Site ID: SAC_18-1_L]	38.165945 °	38.165498 °	17	
								-121.599345 °	-121.600080 °	Y	
								DWR ID:

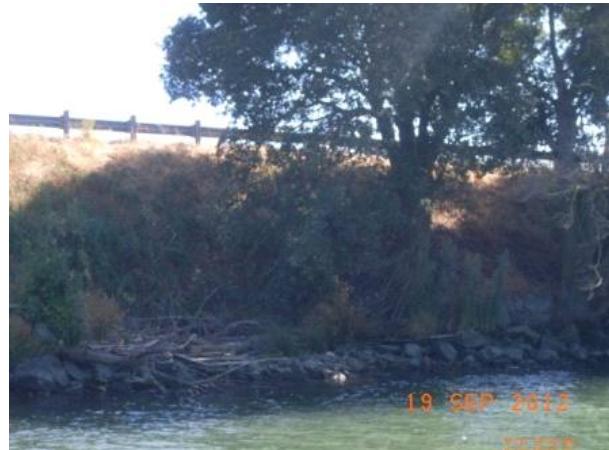
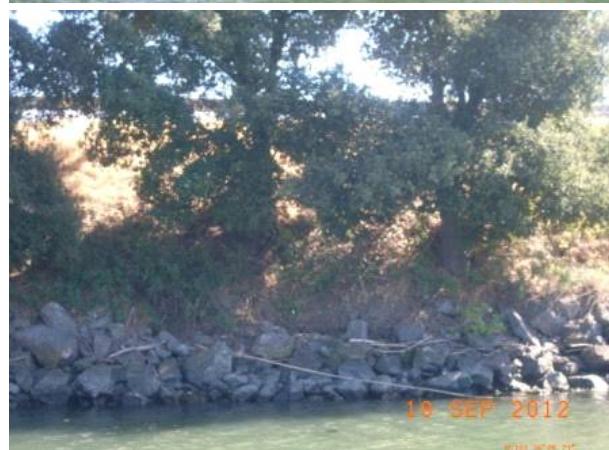
Levee Mile Report Line	16
Start Levee Mile	2.66
End Levee Mile	2.74
Location	Water Side
Category	Supplemental
Item	USACE Erosion Survey

Waterway								Bank	Unit Miles	Inspection Start/End	Inspector
L/MR No	Levee Mile		Category	Item	* Location	* Rating	Action/Comment	GPS Latitude/Longitude		Issue No.	
	Start	End						Start	End		
16	2.66	2.74	Supplemental USACE Erosion Survey	WS	M Ma	Inspector Comments: 2009 - Large scallop from rotational failure. One fallen tree and one large tree with half of its root structure exposed. 2012: No observed change. [2012 Site ID: SAC_18-0_L]	38.165303 ° -121.600477 °	38.164682 ° -121.601804 °	18 Y	DWR ID:	
17	2.93	3.13	Earthen Levee	Encroachments	LS En	M UR : Urban	38.163317 ° -121.604813 °	38.162707 ° -121.608262 °	30 DWR ID: DWR_NA0002_02_s_2012_30		
18	3.17	3.17	Earthen Levee	Trim / Thin Trees	WSA/W Ma	T4 : Trim trees over roadway to at least 12 feet above ground level.	38.162638 ° -121.609068 °	38.162638 ° -121.609068 °	5 Y	DWR ID: DWR_NA0002_02_s_2012_5	
19	3.20	3.20	Earthen Levee	Trim / Thin Trees	WSA/W Ma	T4 : Trim trees over roadway to at least 12 feet above ground level.	38.162643 ° -121.609616 °	38.162643 ° -121.609616 °	6 DWR ID: DWR_NA0002_02_s_2012_6

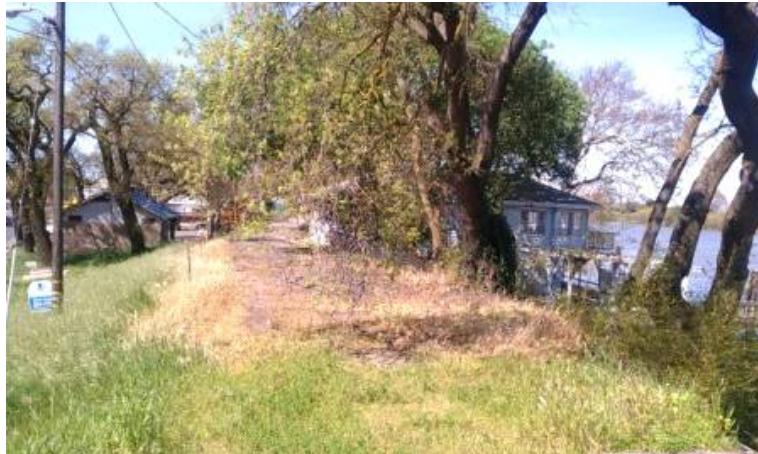
Levee Mile Report Line	18
Start Levee Mile	3.17
End Levee Mile	3.17
Location	Water Side
Category	Earthen Levee
Item	Trim / Thin Trees
Looking south at overhanging tree on waterside shoulder.	
richard_f_20121012_217.jpg

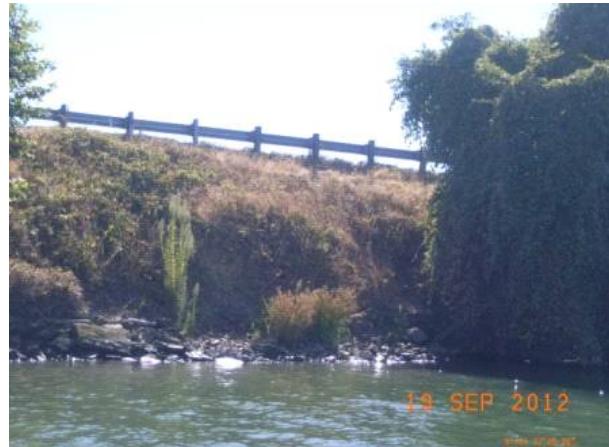
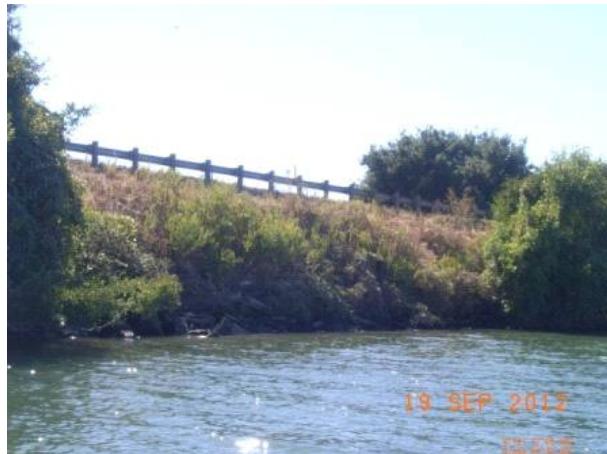
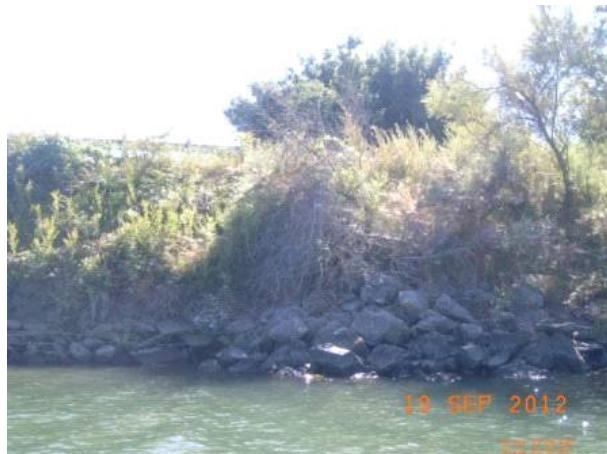
Levee Mile Report Line	23
Start Levee Mile	3.61
End Levee Mile	3.72
Location	Water Side
Category	Supplemental
Item	USACE Erosion Survey

23	3.61	3.72	Supplemental USACE Erosion Survey	WS	U Ma	Inspector Comments: 2008 - Overstepped levee section with pocket erosion. Plans for repair currently in the design phase. 2010 - Very steep slope with slumps, longitudinal cracking, and overturned trees. 2011 - Upgraded to CRITICAL. Sections of vertical slope with highway on top. Heavy vegetation in front of most of the erosion pockets. 2012: No observed change. [2012 Site ID: SAC_16-8_L]	38.162959 ° -121.617323 °	38.163334 ° -121.619312 °	20 Y	DWR ID:	
24	4.01	4.01	Earthen Levee	Trim / Thin Trees	LS Ma	T1 : Trim trees to at least five feet above ground level.	38.164470 ° -121.624012 °	38.164470 ° -121.624012 °	31 DWR ID: DWR_NA0002_02_s_2012_31		
25	4.04	4.15	Earthen Levee	Vegetation	LS En	U V6 : Landscaping	38.164498 ° -121.624343 °	38.165167 ° -121.626273 °	59 DWR ID: DWR_NA0002_02_s_2012_59		
26	4.47	4.47	Earthen Levee	Trim / Thin Trees	LS A/W Ma	T1 : Trim trees to at least five feet above ground level.	38.167135 ° -121.631662 °	38.167135 ° -121.631662 °	32 DWR ID: DWR_NA0002_02_s_2012_32

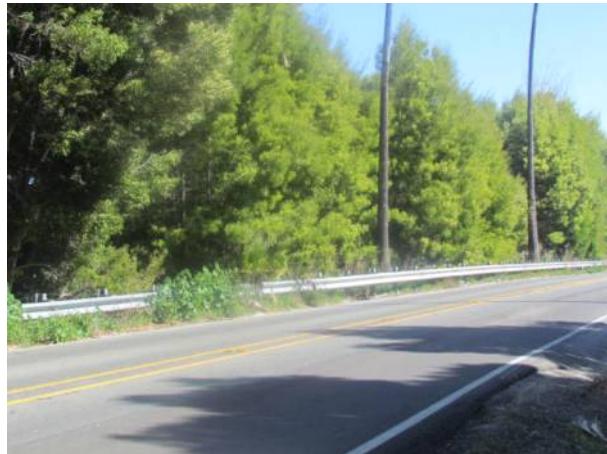
Looking southeast at dense trees on landside slope and toe.

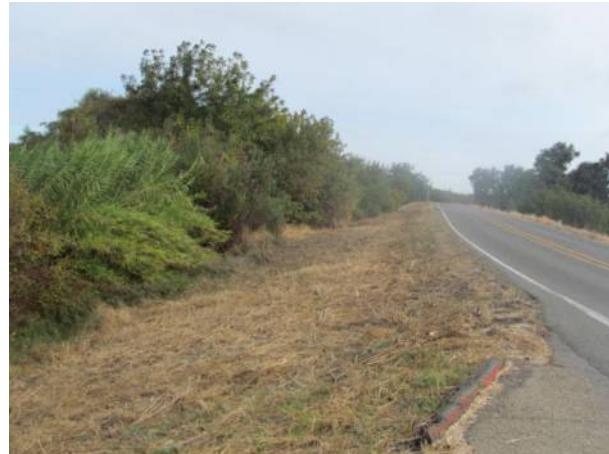
Levee Mile Report Line	29
Start Levee Mile	5.66
End Levee Mile	5.70
Location	Water Side
Category	Earthen Levee
Item	Vegetation
Looking northwest at vegetation complies on waterside slope.	
richard_f_20121029_899.JPG

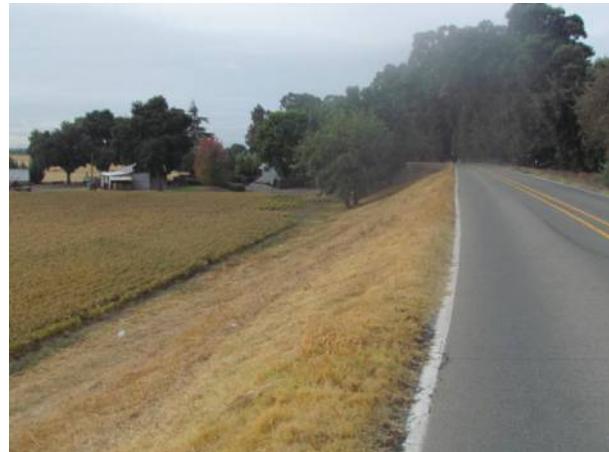
Looking southeast at vegetation complies on landside slope.

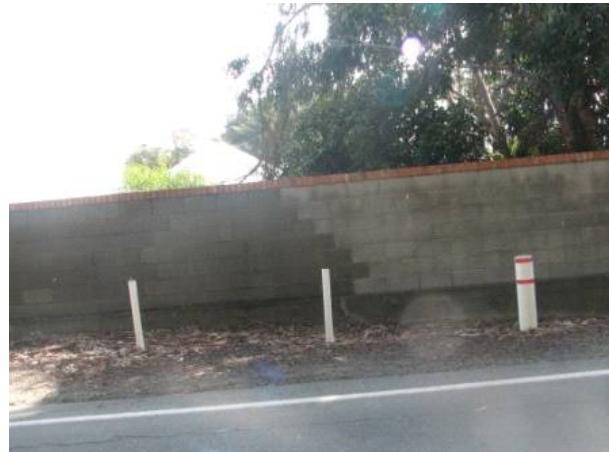
Brick wall on landside shoulder at LM 6.82.

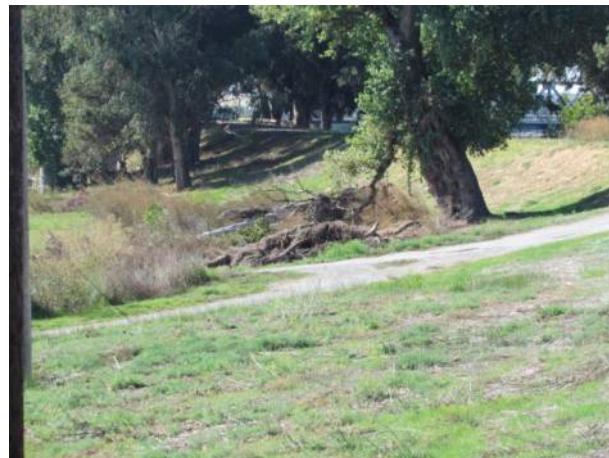
Levee Mile Report Line	36
Start Levee Mile	7.66
End Levee Mile	7.66
Location	Land Side
Category	Earthen Levee
Item	Encroachments
Looking south at prunings on landside toe.	
richard_f_20121012_237.jpg

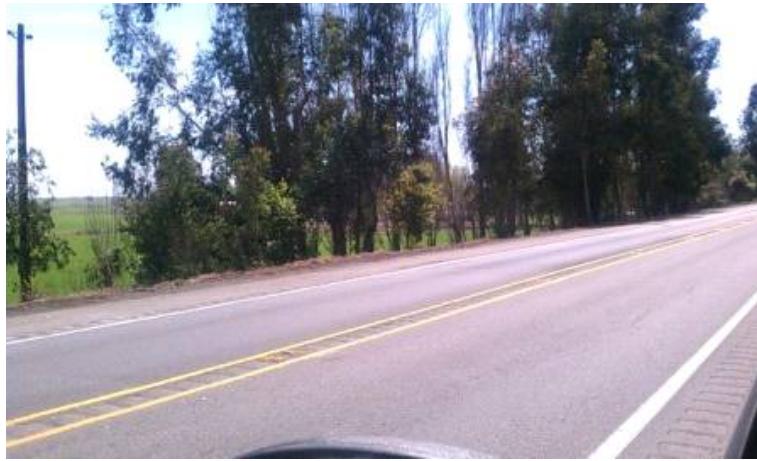
Levee Mile Report Line	38
Start Levee Mile	8.35
End Levee Mile	8.71
Location	Land Side
Category	Earthen Levee
Item	Trim / Thin Trees
Looking southeast at trees on landside shoulder and slope.	
richard_f_20121012_250.jpg

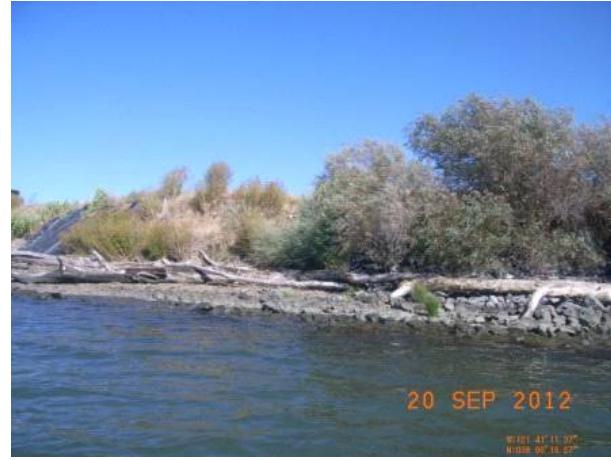
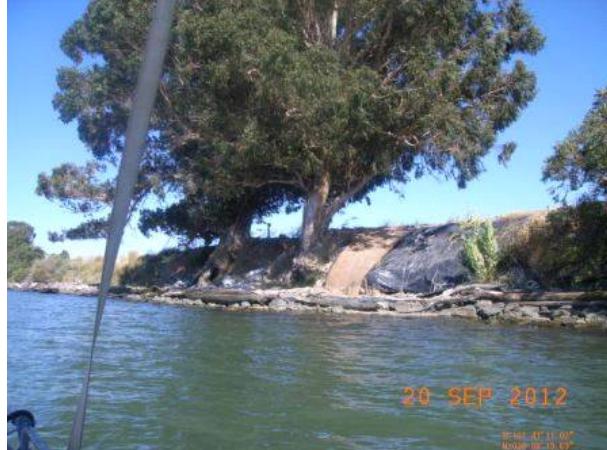
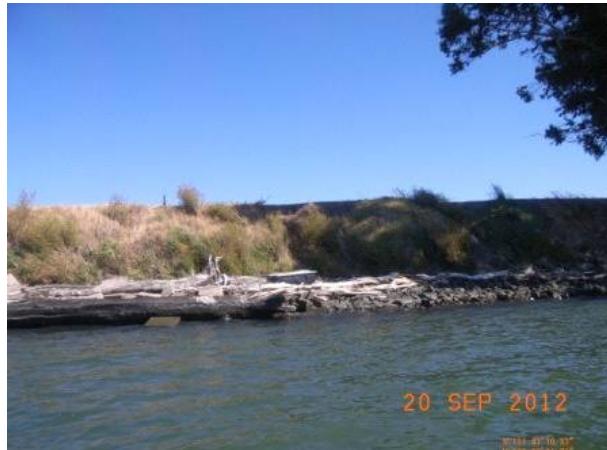
Levee Mile Report Line	40
Start Levee Mile	8.95
End Levee Mile	9.17
Location	Water Side
Category	Supplemental
Item	USACE Erosion Survey
USACE 2012 Photo #1	
USACE2012_SAC_11-2_L_1.jpg

Waterway							Bank	Unit Miles	Inspection Start/End	Inspector			
L/MR No.	Levee Mile		Category	Item	* Location	** Rating	Action/Comment			GPS Latitude/Longitude	Issue No.		
	Start	End					Start	End	Photo				
40	8.95	9.17	Supplemental USACE Erosion Survey	WS	U	Ma	Inspector Comments: 2008 - Erosion causing vertical bank at the highway on top of levee. The whole bank along the highway should be repaired. 2009 - Minimal new erosion. 2011 - Bank continues to slowly erode. 2012: Upgrade to critical, new erosion since last year and steeper slopes in sections. [2012 Site ID: SAC_11-2_L]	38.141399 °	38.138158 °	38	-121.685346 °	-121.686531 °	Y
41	9.42	9.42	Earthen Levee	Trim / Thin Trees	WSA/W	Ma	T1 : Trim trees to at least five feet above ground level.	38.135106 °	38.135106 °	15	-121.686065 °	-121.686065 °	DWR ID: DWR_NA0002_02_s_2012_15
42	9.68	9.74	Earthen Levee	Vegetation	WSA/W	Ma	V2 : Remove the wild growth other than native grasses from the levee slopes.	38.131448 °	38.130537 °	16	-121.686432 °	-121.686737 °	DWR ID: DWR_NA0002_02_s_2012_16

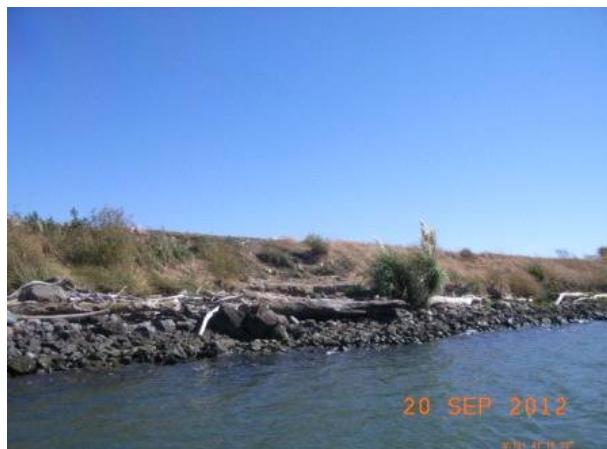
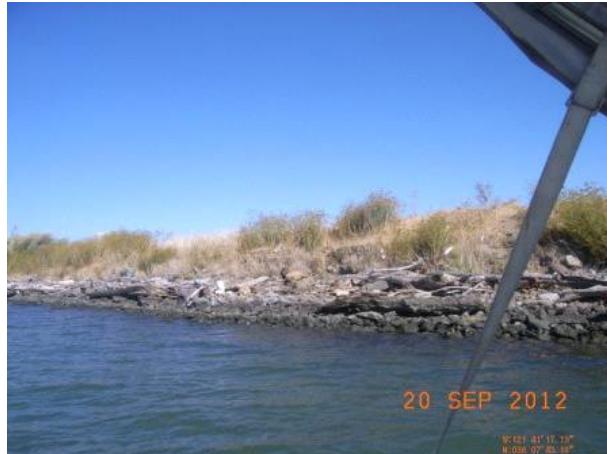
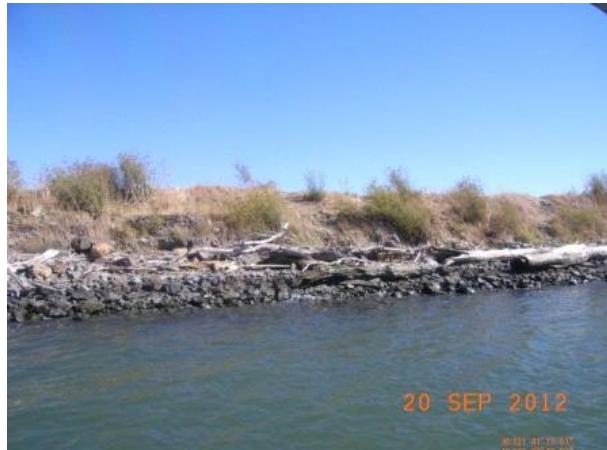
Levee Mile Report Line	43
Start Levee Mile	9.85
End Levee Mile	9.98
Location	Water Side
Category	Supplemental
Item	USACE Erosion Survey

43	9.85	9.98	Supplemental USACE Erosion Survey	WS	M	Ma	Inspector Comments: 2004 - Wave wash pockets approximately 100 ft long with new full bank rock between the pockets. 2005 - Spot repairs, but toe is still eroding in several places. 2006 - Low vertical bank along roadway. 2007 - A PL 84-99 repair was constructed, it cover the majority of the site with the exception of the upstream 150 to 200 ft and the downstream 250 ft, therefore it is being kept in the inventory. 2009 - Minimal new erosion. 2010 - Outboard berm looks good, but the banks are still very steep. 2011 - While the outboard berm is protecting against wave wash, bank still has slumping issues. 2012: No observed change. [2012 Site ID: SAC_10-8_L]	38.129722 °	38.127672 °	39	-121.687468 °	-121.688646 °	Y
											DWR ID:
